Visual Inspections

by Don A. Genutis
Hampton Tedder Technical Services

THIS IS THE FIRST IN A SERIES OF REGULAR ARTICLES that focuses on electrical inspection methods and technologies that are performed while the electrical system remains energized. Although no-outage inspections can be very valuable tools, always remember to comply with the appropriate safety guidelines when conducting inspections.

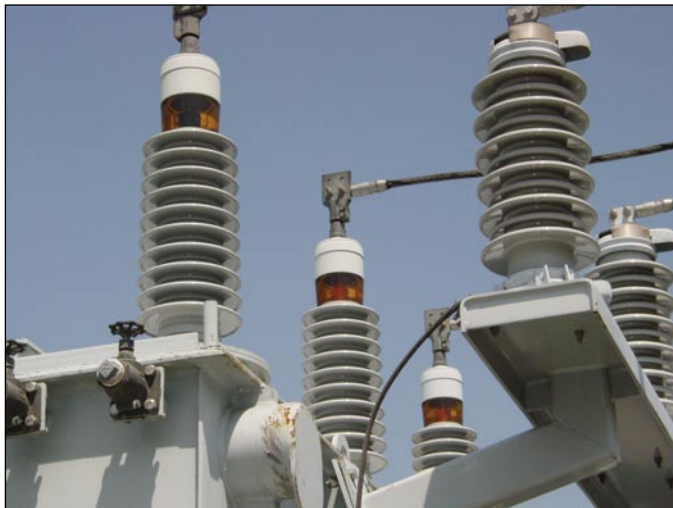
The picture below shows severe color differences between the closest internal bushing conductor compared to the other two phases. This transformer was only a few years old, and utility personnel entered the substation on a daily basis. However, routine visual inspections along with other maintenance procedures were being deferred due to the utility's need to focus resources on new construction activities related to a sudden local economy boom. The problem was only detected by the casual observation of an outside testing agency's technician who was present on an unrelated switchgear cable problem. After this picture was forwarded to the transformer manufacturer, a new bushing was immediately on its way to the utility at no charge. This casual visual observation by the trained eye of a conscientious technician may have saved the utility millions of dollars, had catastrophic bushing failure occurred.

The dark discoloration of the closest internal bushing conductor indicates a potential serious problem in this large substation transformer.
